DOE/NASA/20370-20
NASA TM-82594

Aluminum Blade Development for the Mod-0A 200-Kilowatt Wind Turbine

Bradford S. Linscott and Richard K. Shaltens
National Aeronautics and Space Administration
Lewis Research Center

December 1981

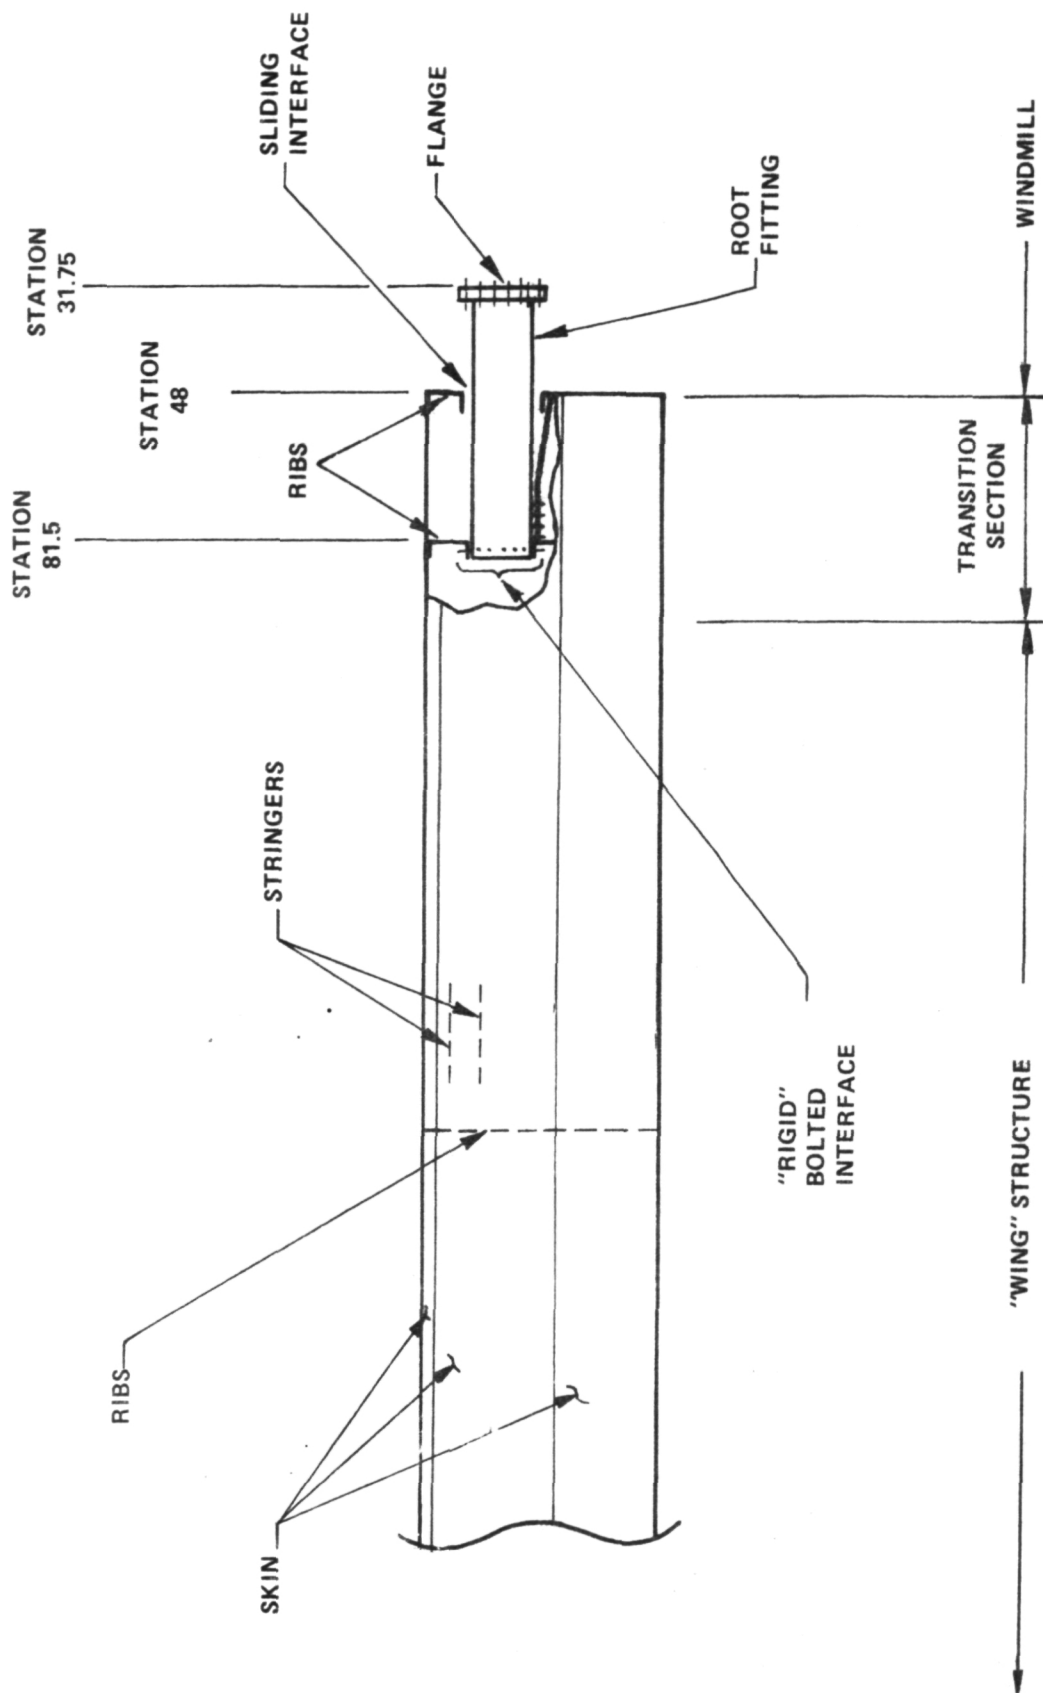
Figure 12. - Mod-OA blade structural schematic.

Figure 12 shows a structural schematic of the blade. The left portion of the assembly is essentially a conventional airplane wing. Structurally, the skins provide most of the section moment of inertia required to resist the bending loads that result during operation. The ribs and stringers locate the skins to maintain the section shape. The right portion of the assembly, the root fitting flange is a standard machine flange. The zone between wing and machine is called the transition section (fig. 12).

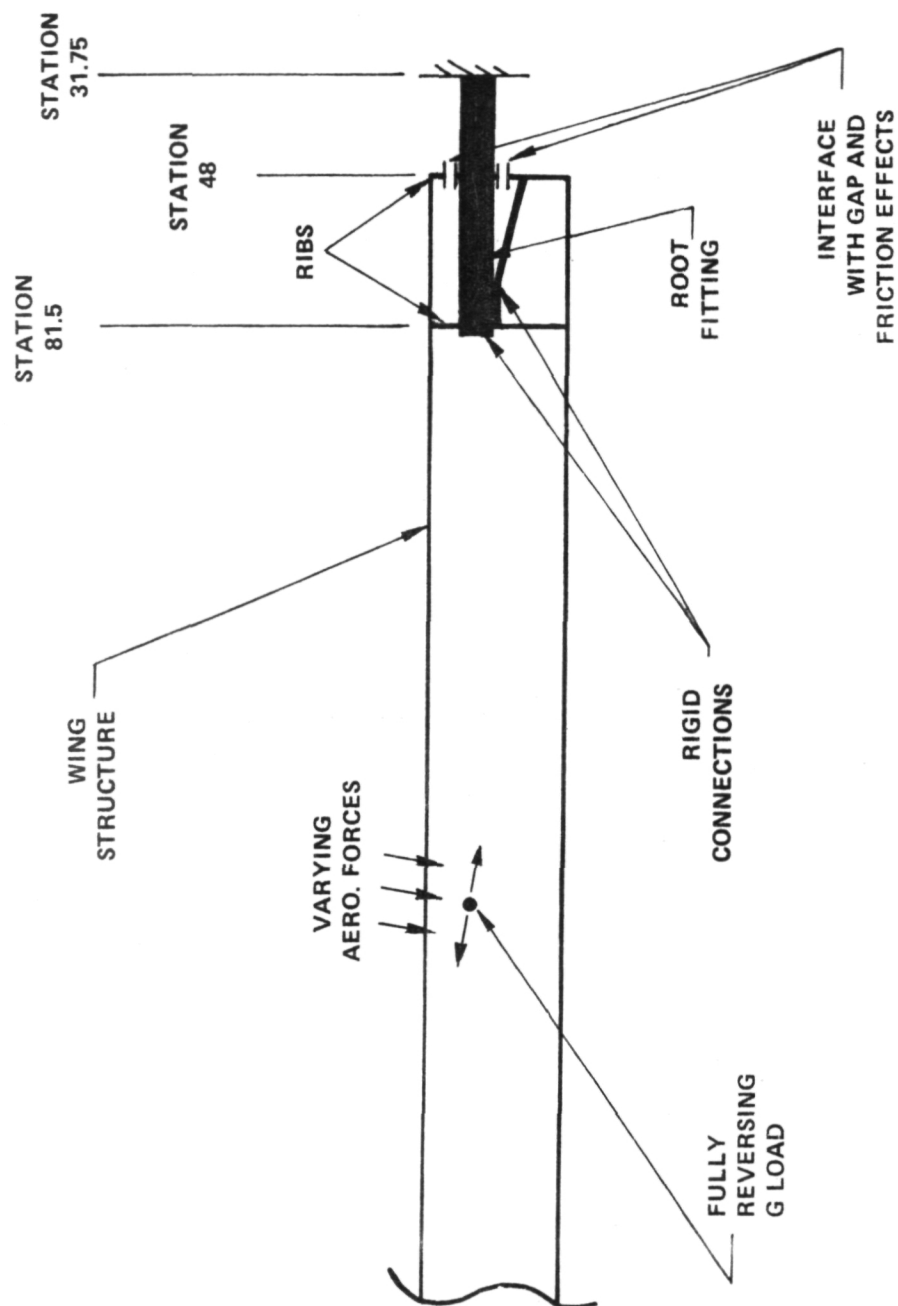
Figure 13. - Mod-0A transition section structural model.

Figure 13 shows a simplified structural model of the transition section. Note that the blade axial loads such as the gravity load (and centrifugal load) are transferred from the wing skins to the root fitting through the station 81.5 rib and the tip of the D-spar web. The gravity load fully reverses each half revolution of the rotor, and this reverses the deflections of the rib and web producing a continuous sliding motion at the root fitting/station 48 rib interface. The blade bending loads are transferred to the root fitting primarily as shear loads at the two root fitting/rib interfaces. Note that, if the gap at the station 48 interface increases due to wear, bending of the station 81.5 rib will occur as the gap at station 48 opens and closes. Also, significant shear forces will develop at the root fitting/station 81.5 bolts and the root fitting/D-spar web bolts. In addition, the steel root end fitting will cyclicly impact the station 48 rib.

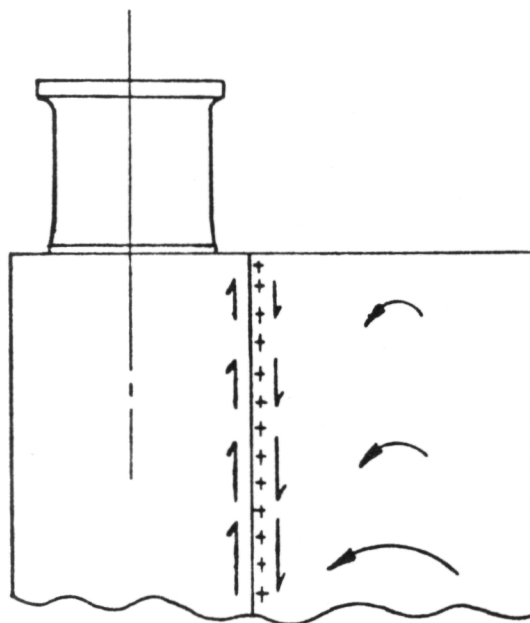
Figure 15. - Mod-OA blade trailing edge - U-spar fastener loads.

During the blade inspection at the Lewis Research Center, three types of blade damage were found. Figure 14 illustrates the nature and location of the damage. The damage included (1) loose and broken fasteners, (2) wear, and (3) cracking. It was concluded that damage at (1) was due to a design deficiency located along the line of fasteners joining the trailing edge skin to the D-spar (fig. 15). It was determined that the joint could not carry the applied shear loads shown in figure 15. The shear loads occur primarily due to the chordwise bending moments, blade weight being a major contributor. As a result, broken and loose fasteners were found, and cracks were found in several angle stringers located in the root end of the D-spar. This design deficiency was corrected by adding doublers on the exterior of the blade between station 48 and 100 as shown in figures 16 and 17.
